A Defective Endotracheal Tube

W L Chua, A S B Ng

Singapore Med J 2002 Vol 43(9):476-478

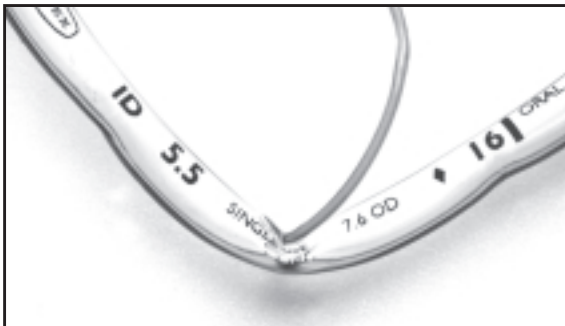
Examination of the kinked tube revealed that it was softer to palpation at a point where the inflation tube for the pilot balloon was attached to the tube wall (Fig. 1), in comparison to an identical size 5.5 cuffed tube with another batch number (Fig. 2). The defective ETT retained the deformed configuration over the next two months despite attempts to straighten it and storage in a cool environment (Fig. 3).

Fig. 1 Photograph showing kink at the junction where the inflation tube is attached to the wall of the ETT.

In our case, the kink occurred at a distance of 13 cm from the tip of the tube, corresponding to the location of the notch in the wall of a size 5.5 ETT. This point is well within the oral cavity at a point just beyond the soft palate, thus making it difficult to detect even with a palpating finger. The only early warning signs were: decreasing tidal volume on a pressure control mode of ventilation and persistently high ETCO₂ due to hypoventilation. The suction catheter was unable to pass through the tube due to the sharp V-shape kink as the tube softens at body temperature.

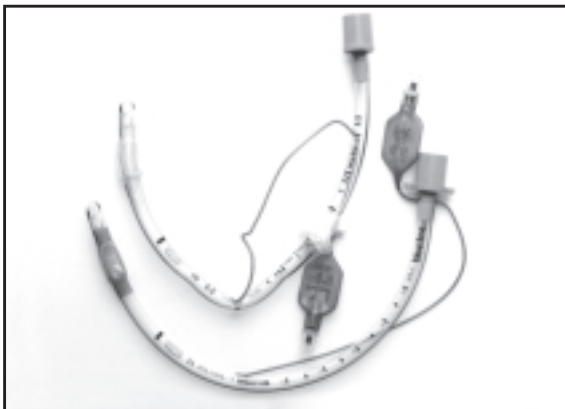
Fig. 2 Comparison of the defective ETT (LOT 210870, REF 100/199/055) with a size 5.5 ETT from another batch (LOT 97A15, REF 100/188/055).

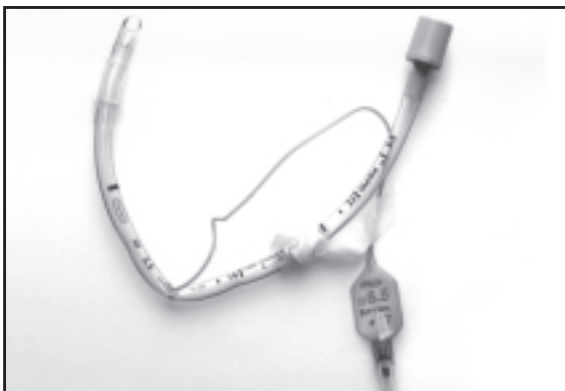
Fig. 3 The defective ETT after 2 months storage in a cool environment.
