# Artefactual spikes in electrocardiography: a worthwhile introspection

*Keywords: artifacts, electrocardiography, implanted neurostimulator*  
*Singapore Med J 2013; 54(2): e46–e49*

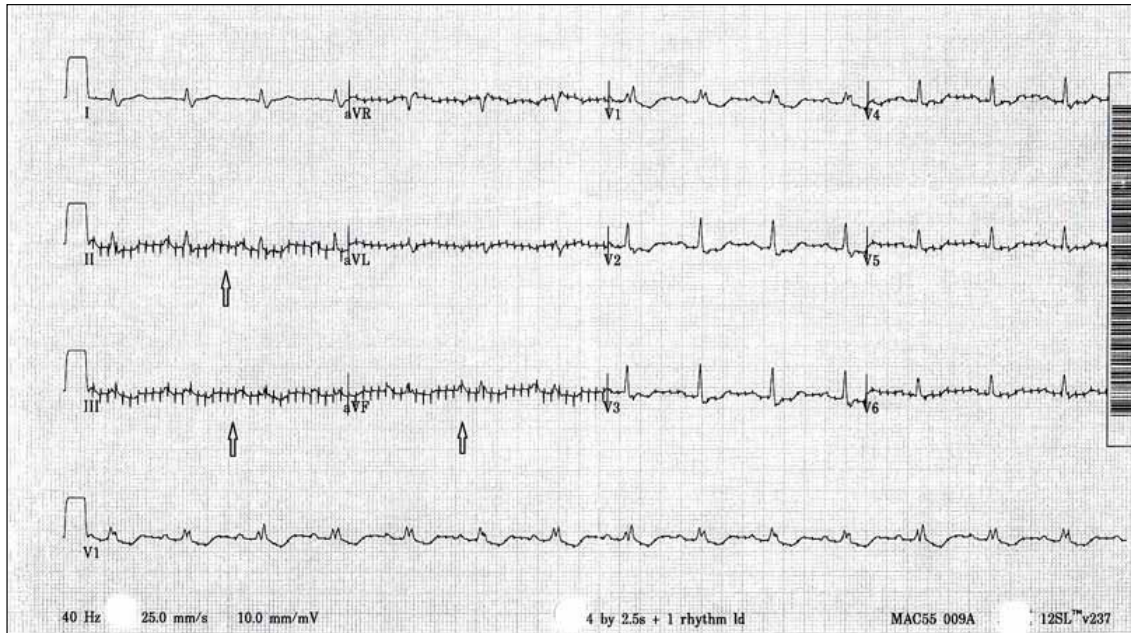
The patient's ECG revealed a normal sinus rhythm and an old right bundle branch block. No ST-T changes were noted. However, ECG also revealed regularly placed small spikes in the frequency of 14 Hz in all leads, more prominently in the inferior

leads II, III and aVF (Fig. 1). This is evident in Fig. 2, which shows 14 up and down wave patterns in a given second (25 squares). As the disturbances were more prominent in the inferior leads, this suggested that the cause of the artefact was closer to the left leg (Table I).

The spikes in the ECG were uniform, clearly indicating that the recorded electrical activity was from an external device emitting electrical discharges at a constant frequency. Alternating current (AC) interference from an external source was ruled out since the ECG showed low frequency spikes (14 Hz) and AC usually has a wavelength of 60 Hz. Hence, judging from the stability of the spikes and prominence in the leads closer to the source of disturbance, the interference detected in the patient's ECG was assumed to be due to a device that was not from an external source.<sup>(2)</sup> It was eventually found that these spikes were due to the electrical interference by a sacral nerve stimulator

**Fig. 1** ECG of the patient shows electrical disturbance in the form of regular spikes. Electrical interference is more prominent in the inferior leads (arrows).

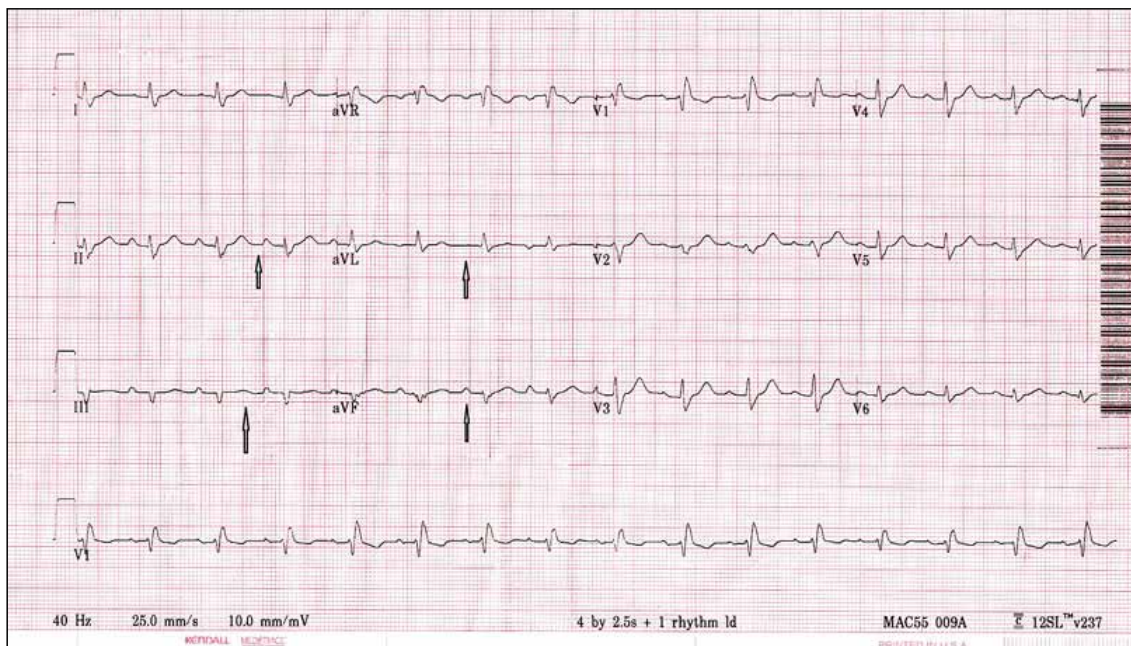
**Fig. 2** ECG of the patient after removal of the bladder stimulator shows areas with no disturbance (arrows).

After one year, the patient had sepsis of the bladder stimulator pocket and it was subsequently removed. Repeat ECG at that time revealed normal waves without any electrical interference (Fig. 3).

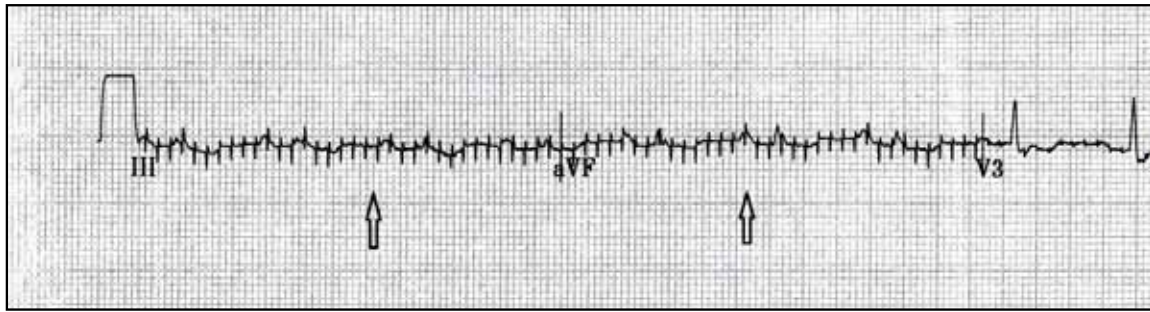
Fig. 3 Magnified view of the regularly spaced spikes in lead III and aVF.

were not resolved with conventional management. InterStim® II neurostimulator uses mild electrical stimulation of the sacral nerves to influence the behaviour of the bladder, sphincter and pelvic floor muscles. It was set at a rate of 14 Hz and found to be consistent with the artefacts in the patient's ECG. The concomitant use of a bladder stimulator during ECG recording had made it possible to have the bladder stimulator's current recorded via the skin electrodes.
