# Late complications of spontaneous urethral erosion of malleable penile prosthesis in a young patient

*Keywords: complication, erectile dysfunction, penile prosthesis, urethral erosion*  
*Singapore Med J 2012; 53(6): e120–e121*

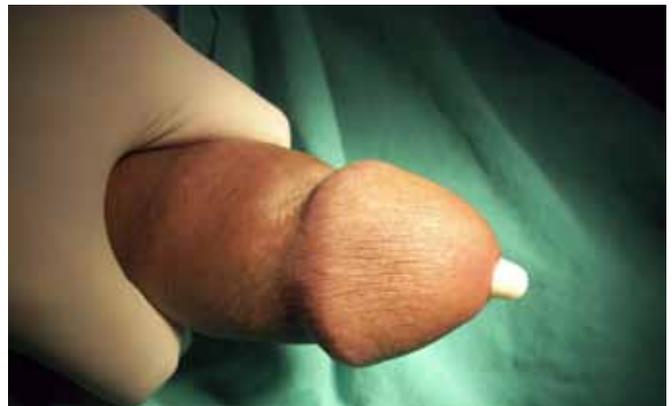
**Fig. 1** Photograph shows the tip of the left-sided penile prosthesis through the fossa navicularis of the meatus urethra.

On physical examination, erosion of the left penile prosthesis was demonstrated through the fossa navicularis of the distal urethra, while the right side was safe in an intact corpora cavernosum (Fig. 1). As extraction of the prosthesis could not be managed at the outpatient clinic, the patient was hospitalised. The 24-cm, left-sided malleable penile prosthesis was extracted under regional anaesthesia with a subcoranal incision (Fig. 2). An approximately 45-degree curve deformity was noted on the extracted prosthesis. No erosion was noticed on the contralateral side, and re-implantation was not done for the ipsilateral side at the same session. Although pre-operative urinary culture was negative and there were no findings suggestive of infection in

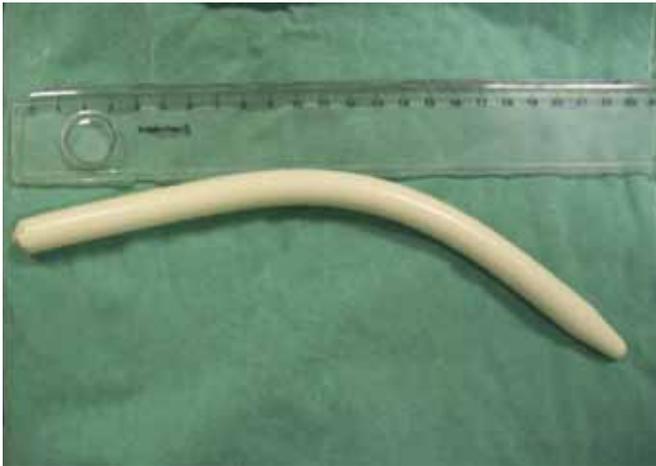
**Fig. 2** Photograph shows the extracted 24-cm malleable penile prosthesis with a spontaneous curving deformity, possibly occurring intracorporeally during the past 23 years.

In cases of urethral erosion of the malleable penile prosthesis, the rods protrude from the urethra, and thus, extraction from the urethra as a simple office procedure has been suggested.<sup>(1-3)</sup> However, in our case, simple extraction could not be managed in the outpatient clinic and the patient underwent extraction with a corporotomy under regional anaesthesia. One possible reason for our failed attempt with simple manoeuvres could be that the rod had integrated with the neighbouring tissue in the course of the past two decades. To support this theory, subsequent forced extraction of the prosthesis was required during the procedure at the operating theatre. We did not consider replacement of the prosthesis, as there was a possibility of infection, and the contralateral side was intact. One-sided intact rods have been reported to be sufficient for adequate coitus.<sup>(1)</sup> The extracted prosthesis had a spontaneous bending deformity at about 45 degrees, which could be due to the deterioration of the prosthetic material. Interestingly, the patient did not mention any sexual problem associated with it.
