**Metal on metal – removal of an extruding mandibular titanium reconstruction plate with a high-speed electrical surgical drill**

**Singapore Med J 2021, 1–8**

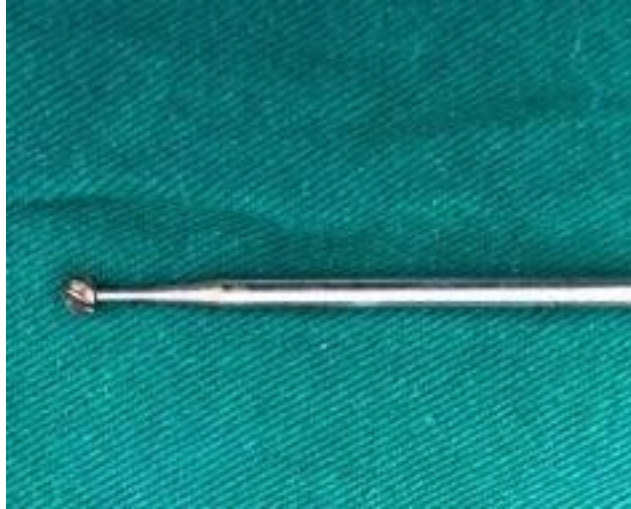
**Figure 1.** 3.2-mm round surgical burr

We present a technique from our institution using the high speed electrical surgical drill with 3.2-mm round bur (Midas Rex® Legend 10-cm long, 3.2-mm head diameter Ball-Fluted burr tool, Medtronic, Minnesota, USA) (Figure 1). This method provides the precision and control that one needs in the removal of extruded mandibular reconstruction plate. Future plate extrusion can also be prevented by smoothening the rough edges of the remaining plate with the same burr.

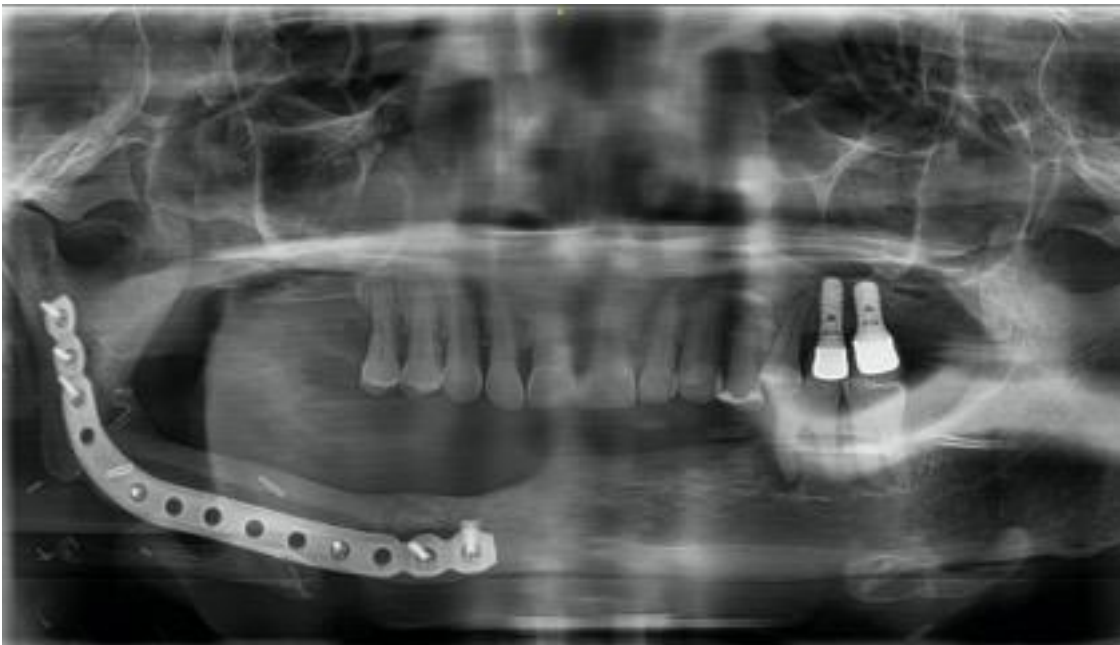
**Figure 2.** Case 1: Preoperative orthopantomogram

Three months after radiation therapy, partial extrusion of the mandibular reconstruction plate occurred. An orthopantomogram (OPG) confirmed the bilateral bony union of the free fibula to mandible (Figure 2). The surgical site did not show any signs of infection around the extruded plate (Figure 3).

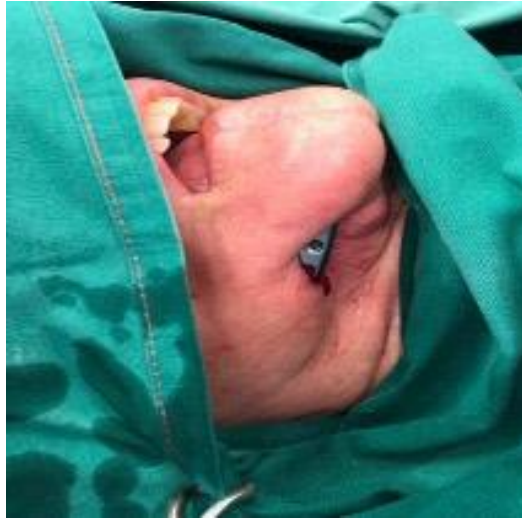
**Figure 3.** Case 1: Preoperative photograph with extruded implant

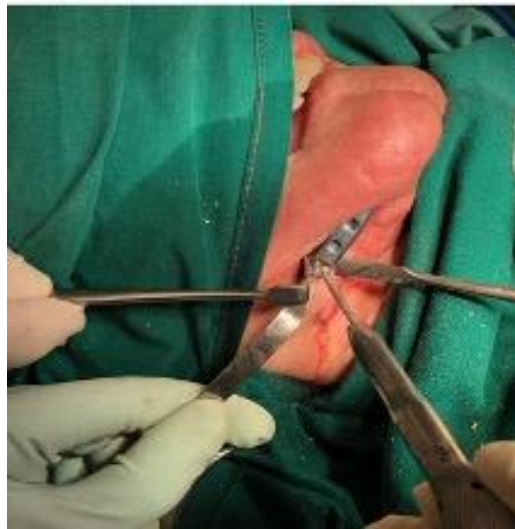
**Figure 4.** Case 1: Intraoperative picture of using 3.2mm round surgical drill. Good soft tissue retraction for protection. Irrigation during cutting to wash away metal debris and dissipate heat.

Plate removal was done following the surgical technique described above. Bearing in mind the importance of locating the correct position of the plate to be removed and ensured adequate soft tissue retraction during the procedure to avoid soft tissue damage (Figure 4). After plate removal, the remaining plate edges were rounded off with the same burr to prevent future extrusion. The wound was washed and closed with PDS 4/0 and Vicryl Rapide 5/0 (Ethicon, Johnson & Johnson, NJ, USA). It healed well with no further plate extrusion (Figure 5).

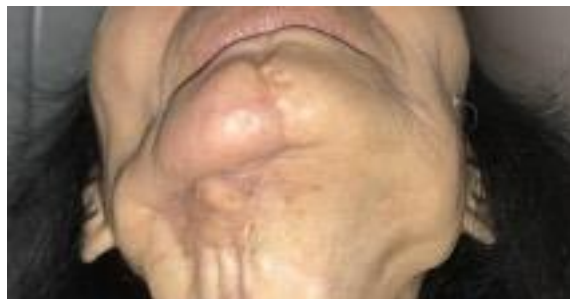
**Figure 5.** Case 1: Post-removal of extruded implant 6 months

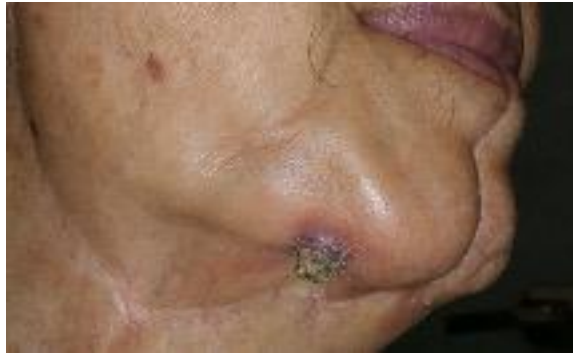
**Figure 6.** Case 2: Granulation tissue overlying extruded implant

A 79-year-old Chinese man underwent right mandibulectomy for SCC of the oral cavity in 1998. Osseous reconstruction with a free fibular flap was performed a month after the resection. Nine years after the resection, part of the plate was exposed with granulation tissue overlying extruded implant (Figure 6). A CT scan showed gross resorption of bone underlying the mandibular reconstruction plate centred around the loose screw. No signs of infection was seen. Plate removal was performed with the similar method described above. It healed well with no further plate extrusion at post-operative one year (Figure 7).

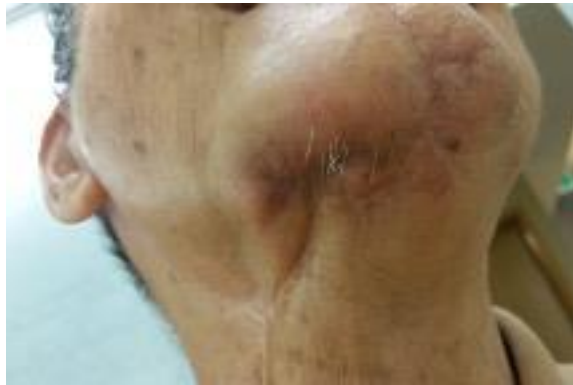
**Figure 7.** Case 2: Post-removal of extruded implant 1 year
